A trial of self-closing bridle gates and a horse-friendly vehicle barrier by The British Horse Society 2011

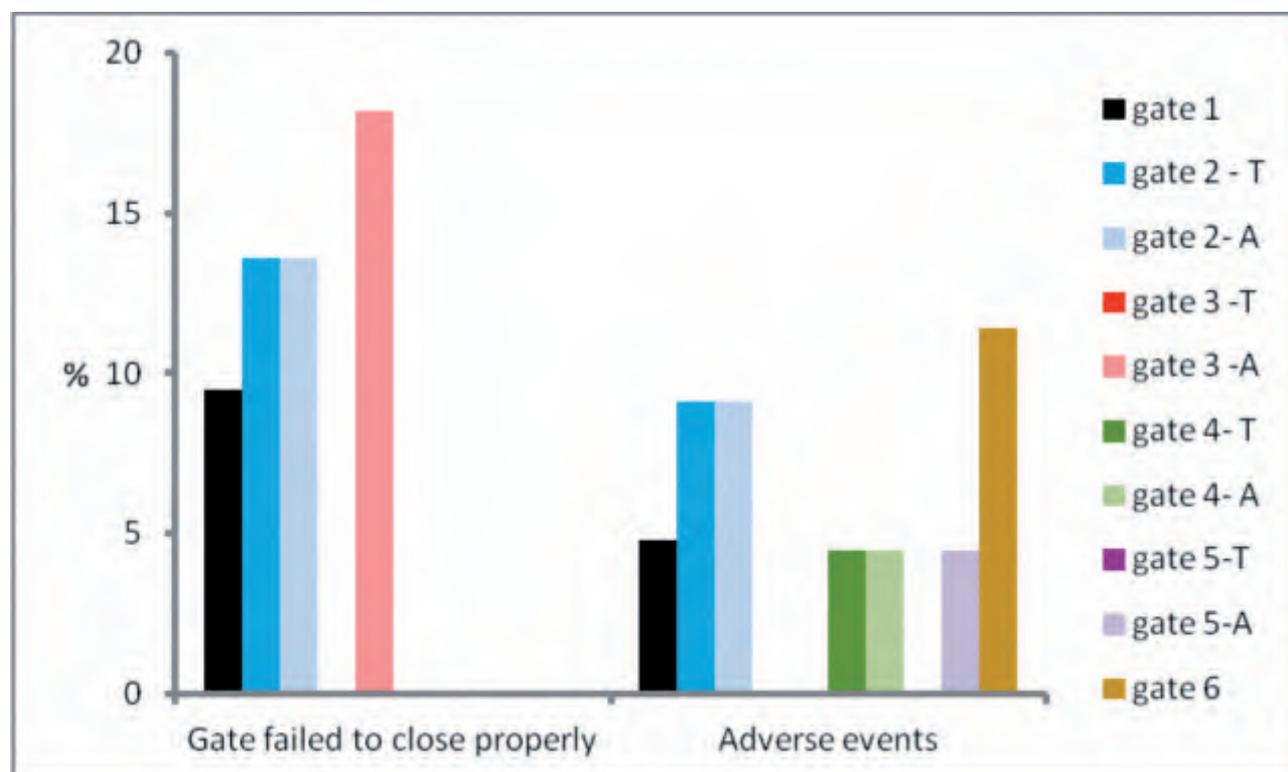
Fig 1: Percentage of occasions when the gate failed to close and latch properly or when adverse events occurred in the main trial

Gates 1 and 6 were two-way gates where riders chose which way to open the gate (not recorded).

Gates 2 to 5 were one-way gates. Data was analysed when riders had to pull the gate towards them (T) or push it away from them (A).

As it is essential that self-closing gates do not injure horse or rider, the potential of each gate to cause an accident was assessed by recording adverse events, that is, when the gate, handle, latch or gate post caught the rider, the horse or the horse's tack. Gate 3 was the only gate not to incur adverse events when ridden in either direction (Fig 1). Gate 5 incurred one adverse event (4.5 percent) but only when pushed away from the rider. Gates 1, 2, 4 (each in both directions) and 6 all incurred adverse events. The number of times when an adverse event almost occurred was also recorded for each gate. When these events were included in the number of adverse events, just under a quarter of riders experienced an adverse event with Gate 6 and with Gate 4 when it was pulled towards the rider.

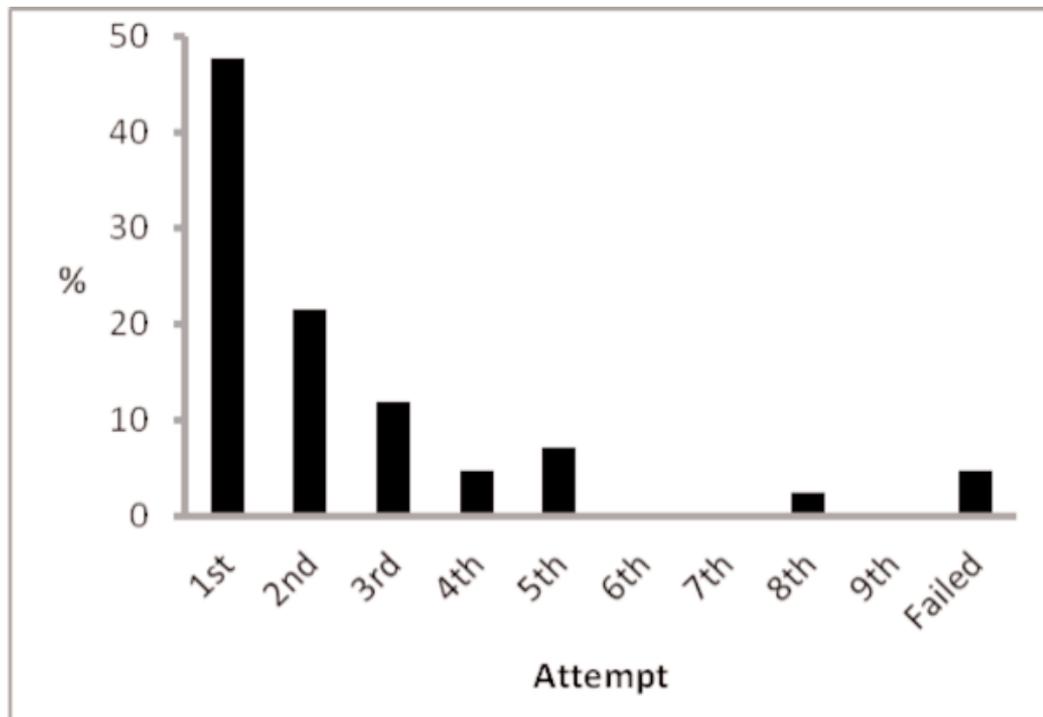
Fig 2: Percentage of successful occasions at the first to ninth attempt, or failing to pass through, gate 1 in the main trial

Twenty-one riders attempted the gate from two directions to give a total of 42 occasions

As an example, the full results obtained for Gate 1 are shown in Fig 2. Riders were unable to pass through Gate 1 at the first attempt in either direction on more than 50 percent of occasions. The majority of riders took two to nine attempts and one rider failed to pass through in both directions (two occasions). For ease of analysis, the third to ninth attempts were pooled to compare ease of use for all gates.

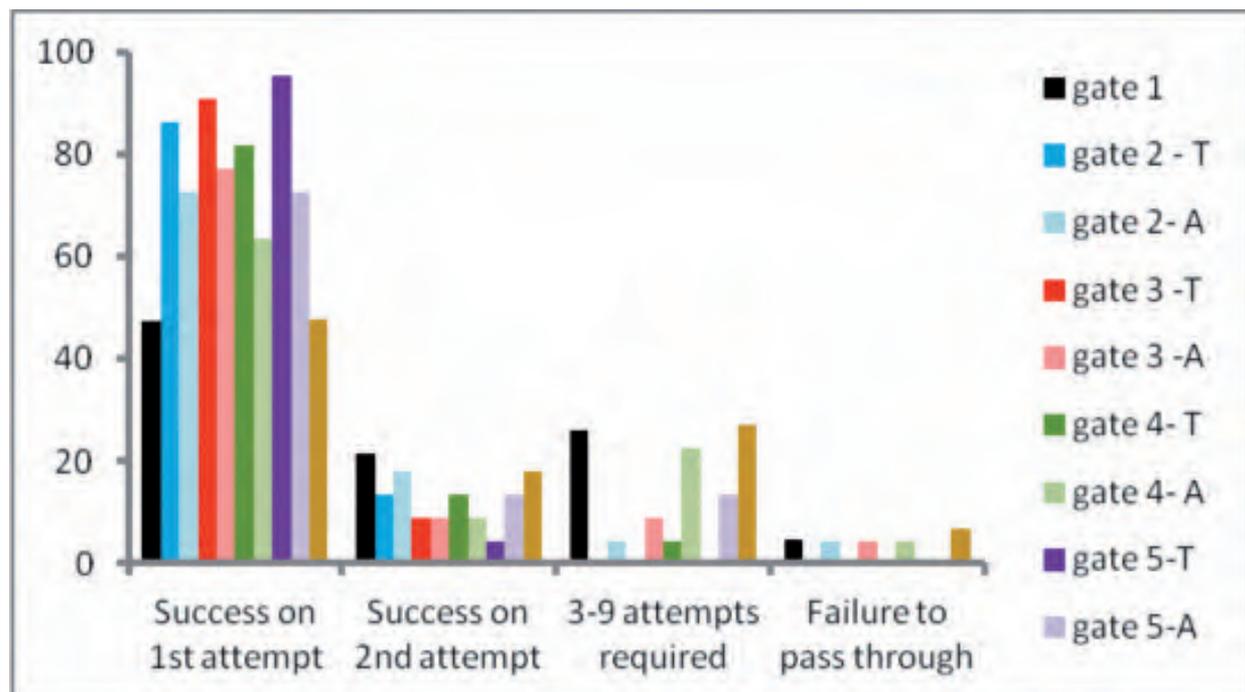
Fig 3: Percentage of occasions when riders passed through Gates 1 to 6 at the first attempt, the second attempt, the third to ninth attempt or failed to pass through the gate in the main trial
Gates 1 and 6 were two-way gates where riders chose which way to open the gate (not recorded).

Gates 2 to 5 were one-way gates. Data was analysed when riders had to pull the gate towards them (T) or push it away from them (A).

The direction in which the one-way gates (Gates 2 to 5) were ridden influenced the ease of use (Figs 3 and 4). Success rates were higher at the first attempt when riders pulled the gates towards them (range 82 to 95.5 percent) than when they pushed the gates away from them (range 64 to 77 percent) (Fig 4). As the two ranges of figures do not overlap, they are significantly statistically different.

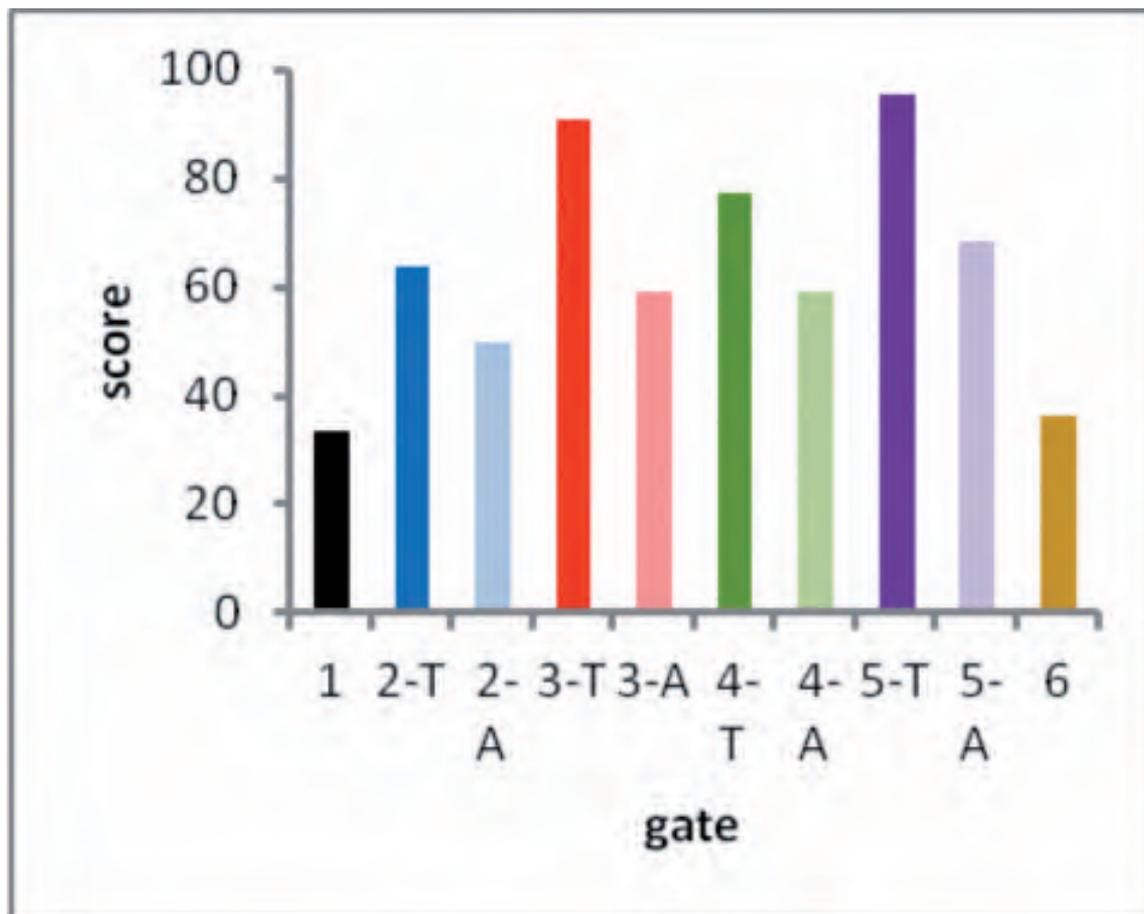
Fig 5: Scores for Gates 1 to 6 in the main trial

°: the score was derived using percentage success at first attempt minus sum of (percentage adverse events + failure to close properly). Maximum score = 100

all occasions (Fig 5). However, it did not fare as well when pushed away from the rider. The gate closed properly but there was one adverse event (4.5 percent) and just over a quarter of riders had to have more than one attempt. This appeared to be because the gate was stiff to push, and despite its slow closing time of 26 seconds it still reclosed on some riders before they could open it sufficiently for their horse to go forward. The practicalities of using Gate 5 are discussed below.

Both the two-way gates, Gates 1 (the Centrewire two-way wooden 'Henley' gate) and 6 (the Centrewire two-way metal H-Frame 'Chiltern' gate) performed poorly with the lowest scores of 33.3 and 36.3 respectively. This was mainly because some riders found them difficult to use safely. Although the majority of horse and rider combinations found it easier to open a gate towards them, some found it easier to open a gate away from them. This might appear to suggest that two-way gates are best by allowing choice, but in this trial both the two-way gates had a poor success rate at the first attempt. This may be partly explained as they both closed faster than their equivalent one-way gates (Gates 3 and 4). Two-way, self-closing gates are also inherently less safe as they require a catch on the inside of the gate post and a prong on the gate to connect with it, which increases the risk of the horse or rider getting caught.

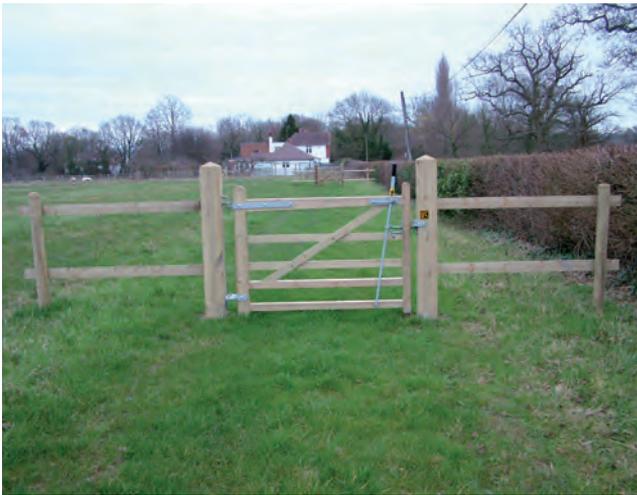
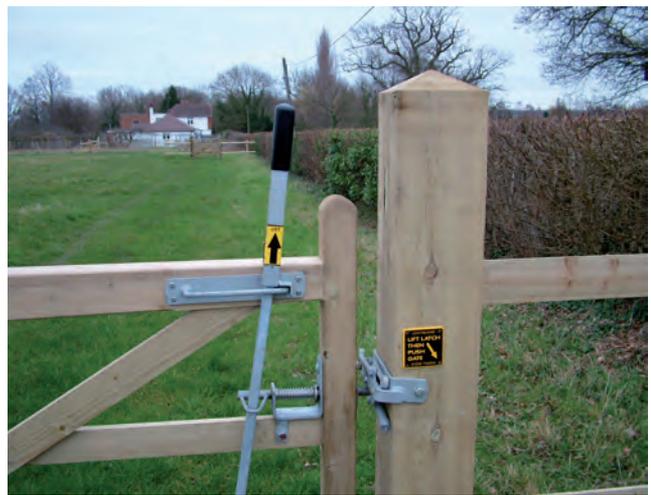
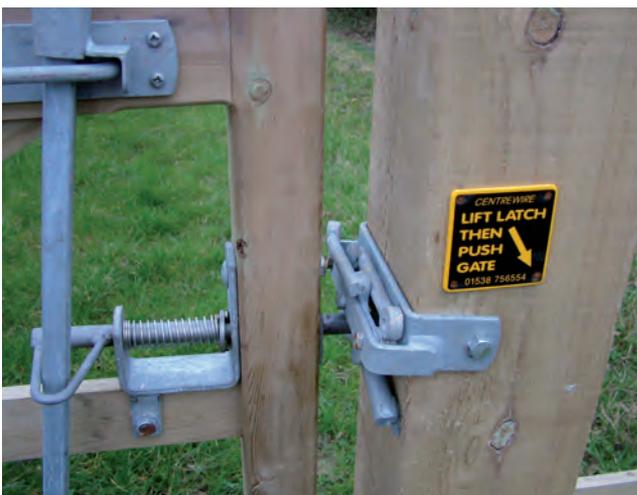
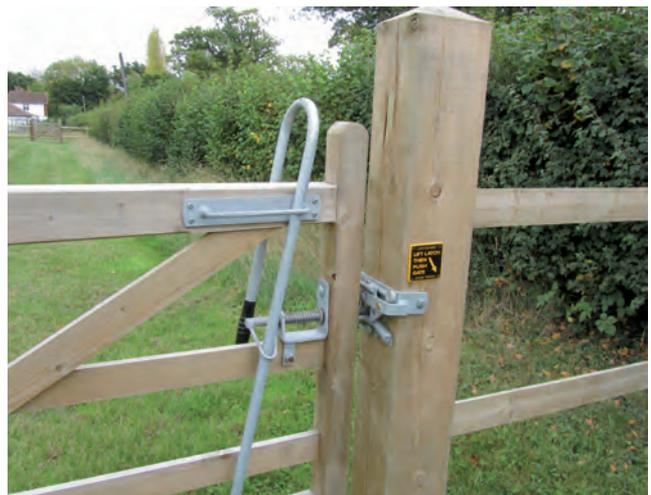
Centrewire wooden 'Henley' two-way bridle gate with stockproof handle. The handle operates a spring-loaded 'easy latch' catch whose prong fits into a two-way catch designed to be helpful to users of mobility vehicles and pedestrians.

For the main trial, the handle was changed to a trombone handle (see lower right hand figure)

- A trombone handle was fitted to Gate 1 instead of the stockproof handle. This did not require any change to the latch mechanism. The prong on the Gate 1 catch was also cut shorter because gate movement had begun to cause the catch to stick.

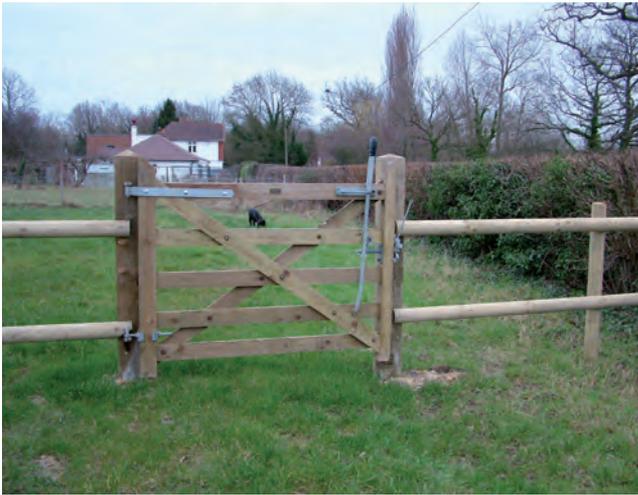
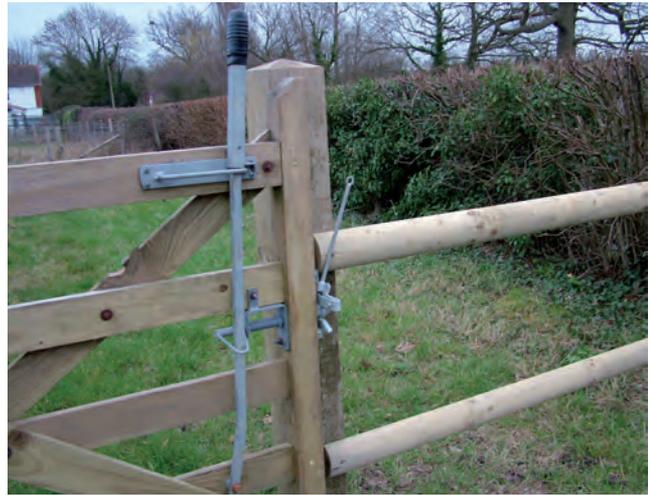
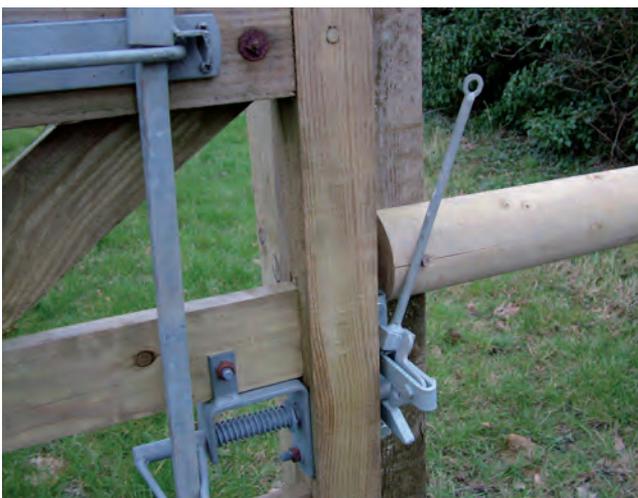
Gate and catch specified: Wooden one-way self-closing gate from another manufacturer with off-set hinges to self-close with auto-latch (extended handle).

Gate and catch installed (initial trial):

Wooden one-way gate with offset hinges. Extended stock-proof handle operated a spring-loaded latch whose unprotected prong closed into an auto-latch with an extended handle.

- The stockproof sprung handle on Gate 2 was removed and replaced with the autolatch with handle and D ring that had originally been planned. It had, in the first instance, been intended that Gate 2 was a very simple gate of the type that most fencing contractors would be able to source locally. It was considered by the observers and participants in the initial trial that the stockproof sprung handle installed by the contractor unnecessarily increased the gate's difficulty of operation. It was also noticeable that the autolatch, as installed, was difficult to reach, performed unreliably and was difficult to see from the far side of the gate when it failed to latch. It also created an additional hazard when it stuck out.

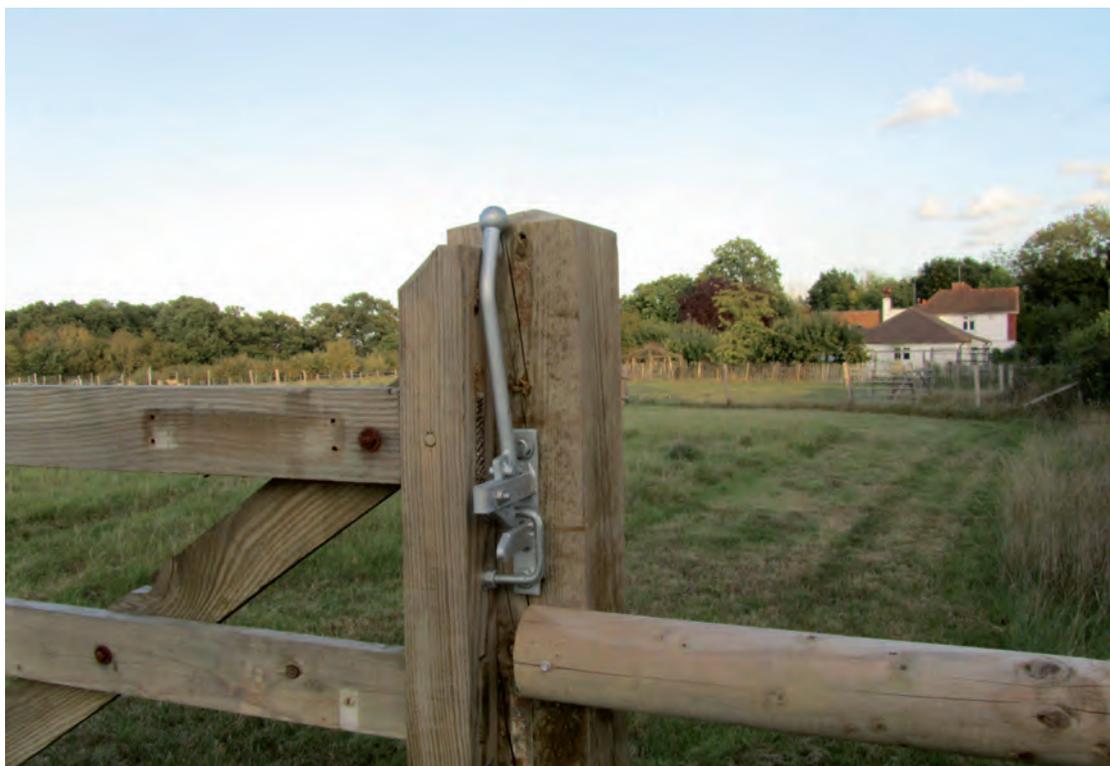
Gate 2 for main trial

Following concern expressed by riders in the initial trial that the autolatch sticking out was a hazard, the extended stockproof handle and spring catch were removed and the extended handle autolatch also changed from the version commonly used in Devon (see above) to the version commonly used in Kent (see below), with a "D ring" on the gate instead of a prong.

Note: to avoid having to re-drill the gate, the contractor initially tried to use part of the Devon catch and part of the Kent catch, but when he did this the gate failed to close reliably. For the balance of the Kent autolatch to work properly, it must be installed as supplied, and in order to be stockproof its handle must not extend above the gatepost.

The D rings on Gates 2 (main trial) and 4 should eliminate the chance of a serious wound being caused by the prong on the gate, though as the trial demonstrated, other adverse events are still possible with these gates. Gate 3 had no adverse events in the trial.

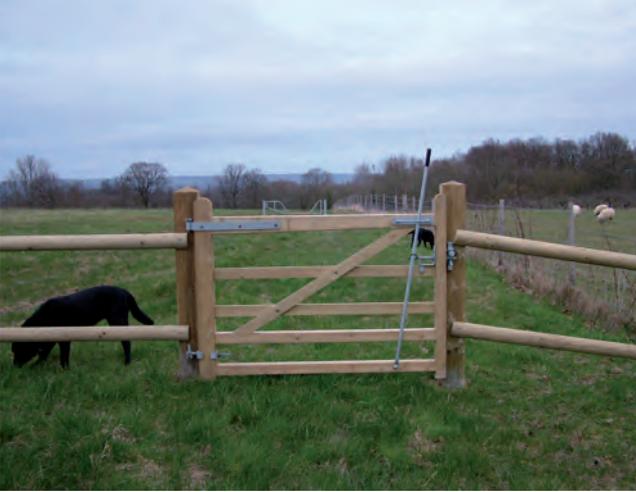
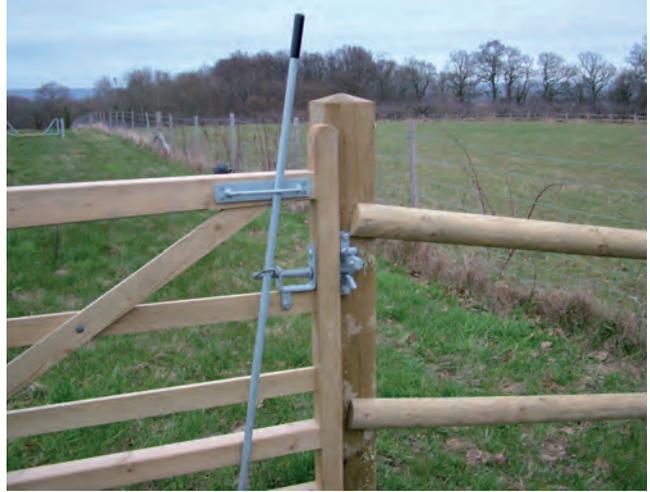
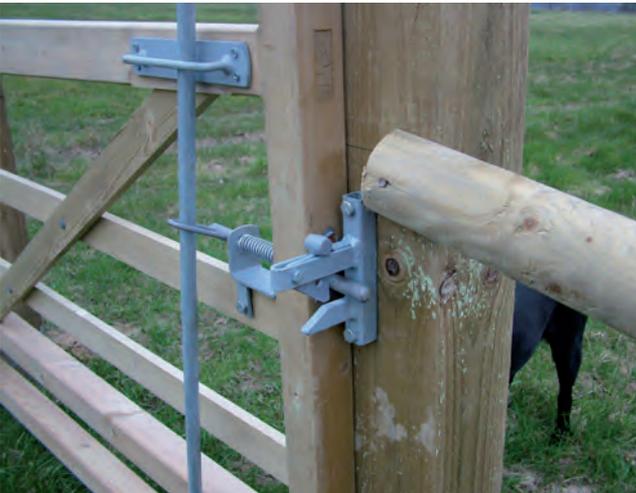
Centrewire wooden 'Henley' one-way bridle gate with extended handle. The handle operates a spring-loaded latch with an unprotected prong into an autocatch.

Gate 3 had one of the highest success rates (90.9 percent) at the first attempt when riders pulled it towards them. No rider required more than two attempts, there were no adverse events and the gate closed properly on all occasions, giving a score of 90.9. However, riders found Gate 3 much less easy when pushed away from them. Some required three to nine attempts or failed to pass through. There were no adverse events but the gate failed to close properly on just under a fifth of occasions when used in this direction, giving a score of 59.

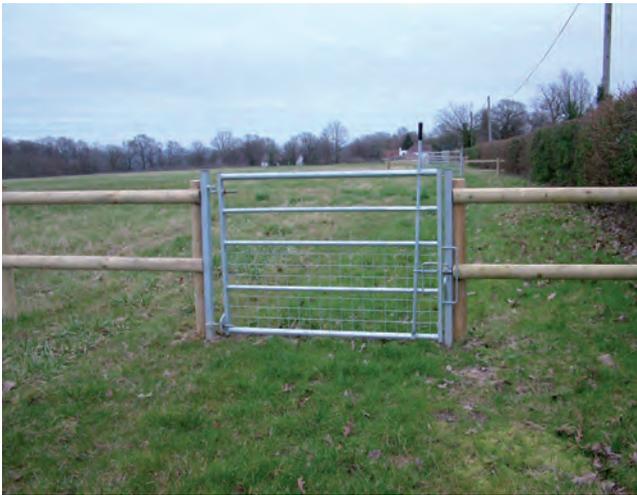
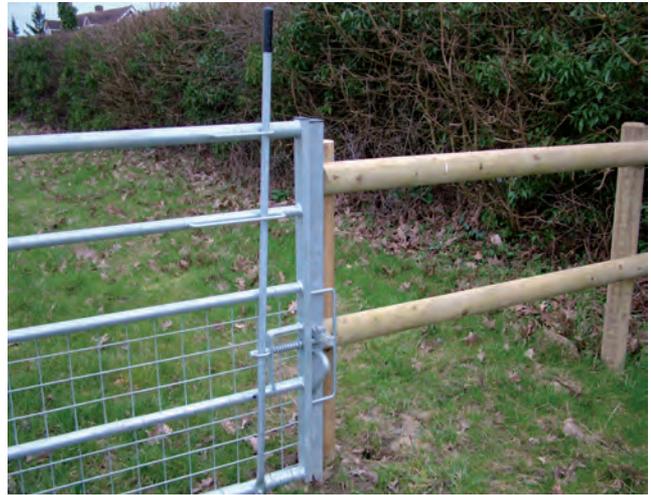
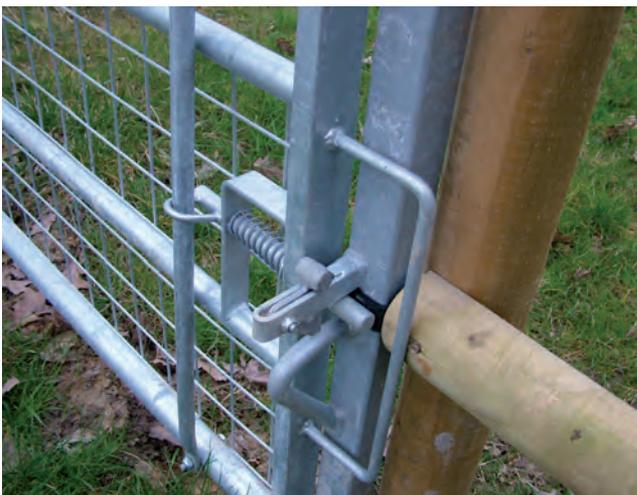
Gate 4

Gate ordered: Centrewire galvanised metal H-Frame 'Chiltern' one-way opening bridle gate with gate stop.

Gate supplied: Centrewire galvanised metal H-Frame 'Chiltern' one-way opening gate. Centrewire initially failed to supply the gate stop, so it was not fitted for the initial trial but was supplied in time for it to be fitted for the main trial. This was necessary to ensure that the gate did not stay open when pushed open to more than 90°. The gate has an extended handle (not stockproof), and a 'D' fitting round the spring-loaded latch which fastens into an autocatch. The gate does not hang straight between the posts because it is hung from the centre of the post at the hinge end and rests against the side of the post at the catch end.

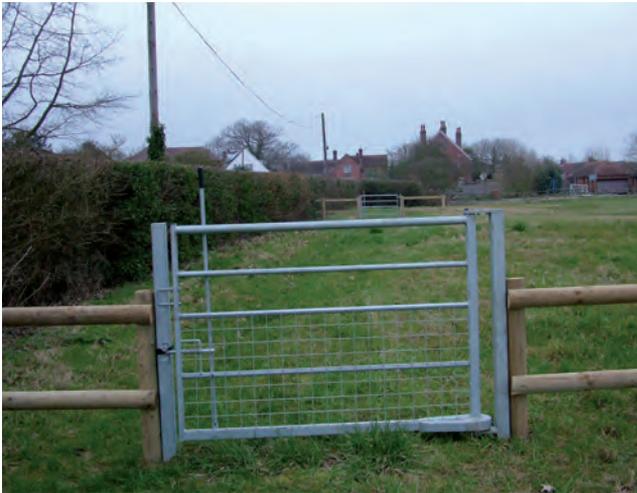
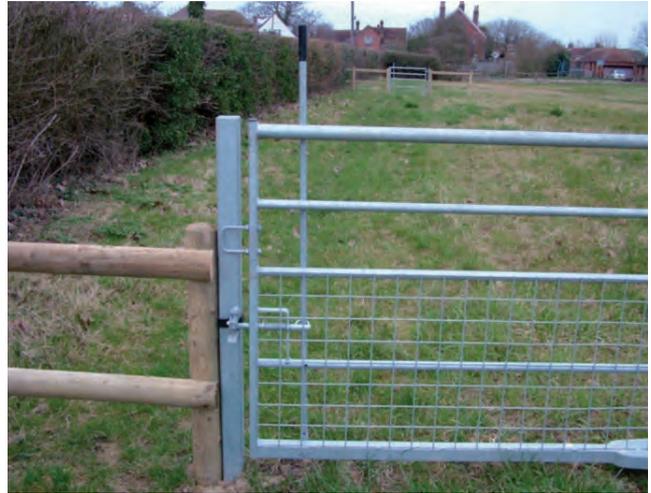
Centrewire galvanised metal 'Worcester' one-way opening bridle gate. The gate has a 'Prosafe' self-closing mechanism (hydraulic and adjustable). The handle operates a spring-loaded latch whose unprotected prong fits into an autocatch. Further up the gate, there is a D-shaped fitting which rests against the gatepost and prevents the gate from opening two ways.

The gate was initially fitted with the speed of closing set as supplied by Centrewire. Adjustment requires a 3mm Allen key which was not supplied with the gate. Nor were the instructions for altering the closing speed initially supplied. The closing speed was adjusted (the process was not easy) to be as slow as possible in time for the main trial.

When, for the main trial, the timing was adjusted to close as slowly as possible (26 seconds in total, of which the last 20° took approximately eight seconds), the gate was felt to be much more rider-friendly. It was noticeable that even when closing as slowly as possible, it self-closed 100% reliably. Moreover, unlike the other metal gates, it did not clang when it closed. However, most riders in the trial found that after passing through the gate they then had to wait for several seconds for it to close completely. Some riders commented (and the observer agrees) that with it set at this speed there could perhaps be a possibility of livestock following the rider and escaping. Although riders were able (and usually needed) to push the gate open again repeatedly while passing through it, there was nothing a rider could do to speed up the gate's closing. Indeed, a rider's attempts to hurry it would only slow it down further. The closing can only be speeded up by adjusting the timing with the Allen key.

The D ring above the prong on Gate 5 should reduce the risk of a tear wound being caused by the prong.

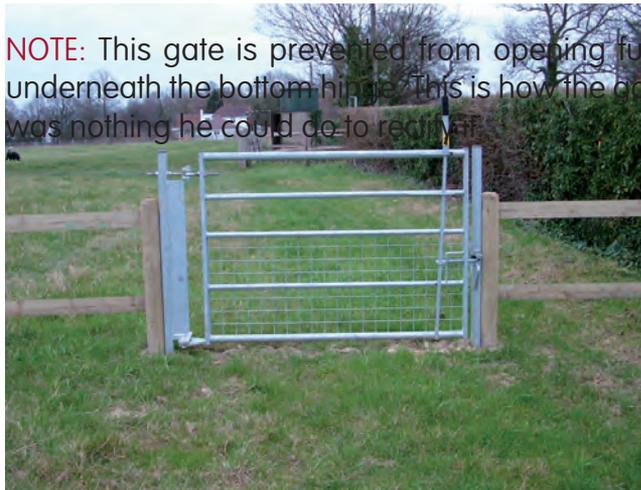
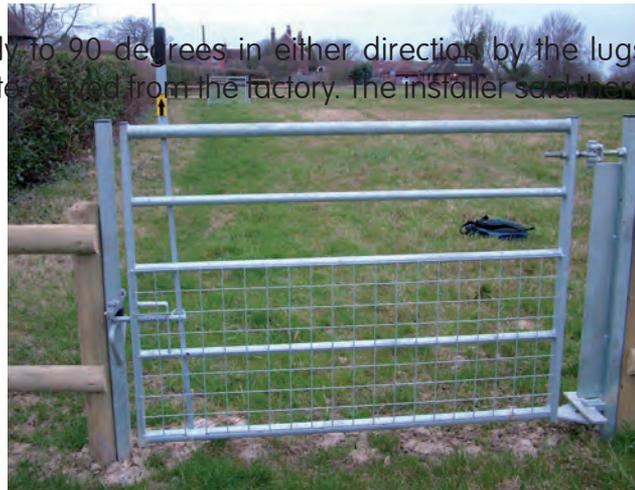
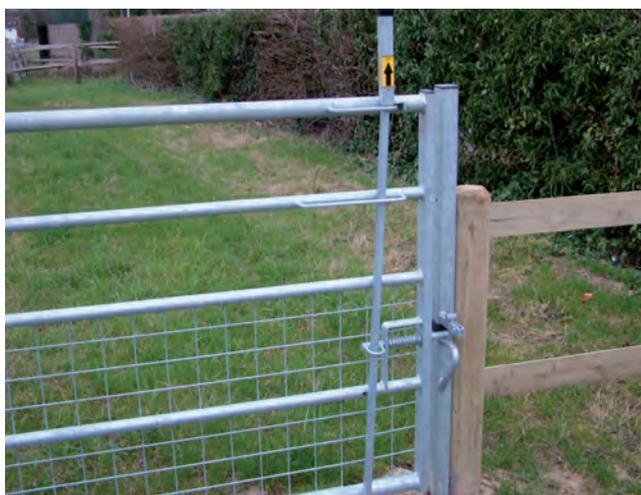
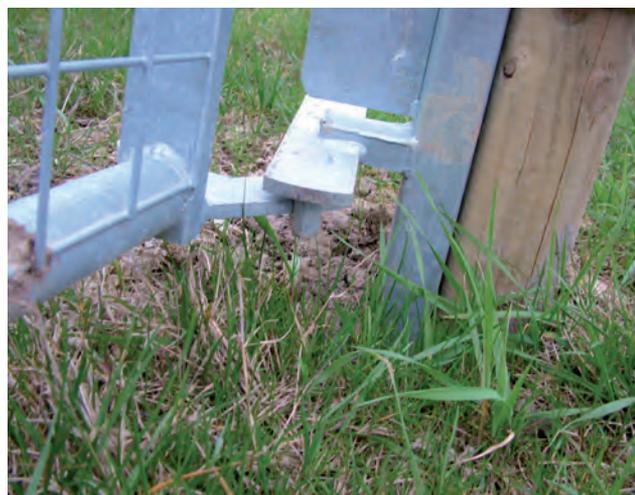
Gate 6

Centrewire metal galvanised H-Frame 'Chiltern' two-way opening bridle gate with stock-proof handle. The handle operates a spring-loaded catch whose unprotected prong fits into one of the autocatches which are mounted on both sides of the gatepost.

NOTE: This gate is prevented from opening fully to 90 degrees in either direction by the lugs underneath the bottom hinge. This is how the gate arrived from the factory. The installer said there was nothing he could do to rectify it.

The Centrewire two-way metal H-Frame 'Chiltern' gate (Gate 6) has metal lugs on its lower hinge which prevent the gate from opening to 90°. Thus, depending on how the rider keeps the gate open, the opening for the rider to pass through could be even narrower than for the other self-closing gates. This failure to open to 90° may explain its speed of closing and also the high level of adverse events which was unacceptable, especially as the riders were all experienced and the installation, ground and weather conditions were ideal. The stockproof handle may have increased this gate's difficulty of use compared with the other gates in the main trial.

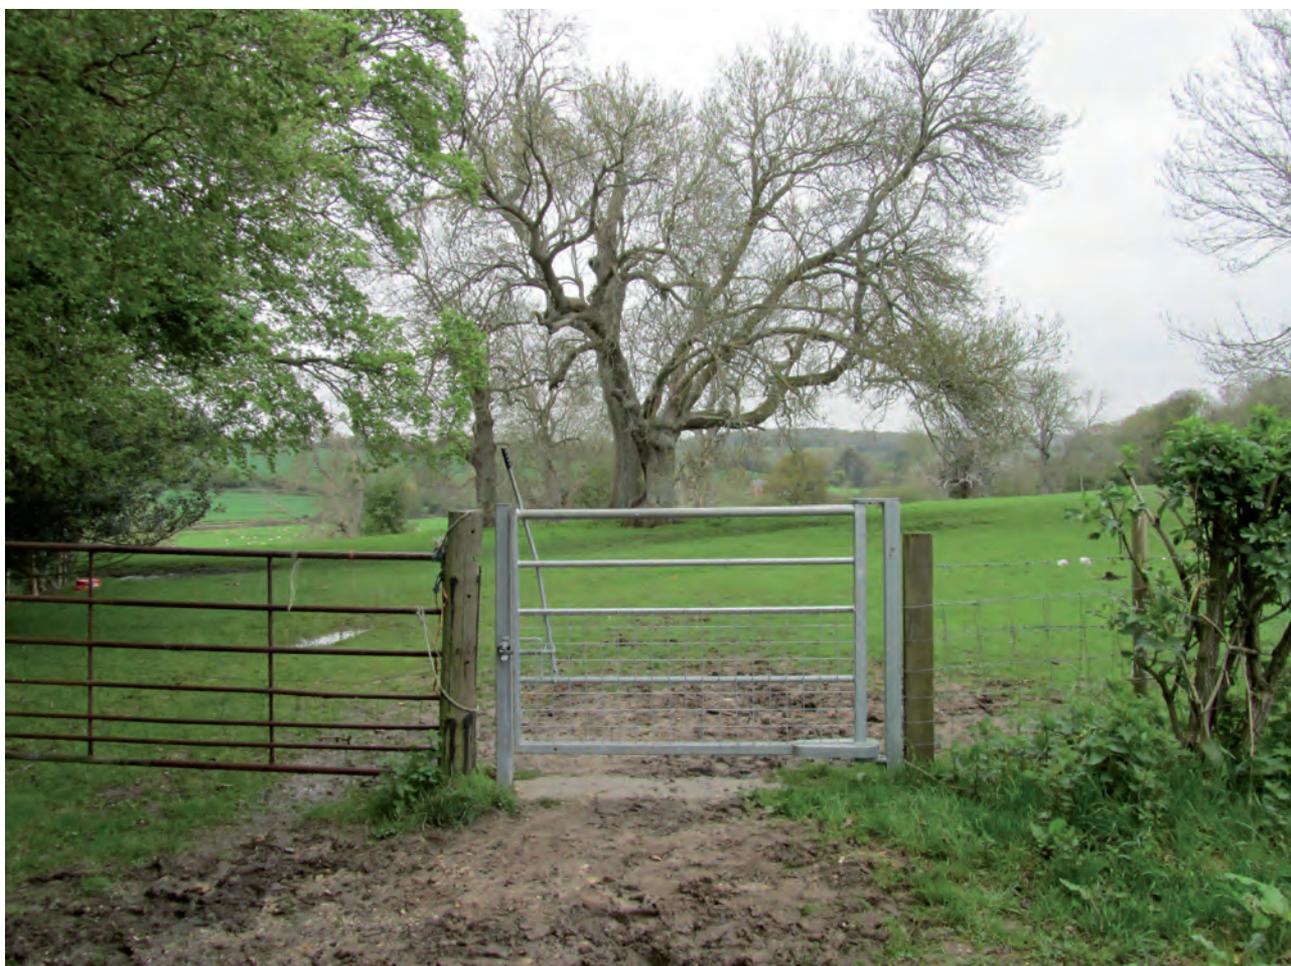
The gate is installed on a field-edge bridleway with 800mm manoeuvring space at the hinge end before a thorn hedge begins, and, at the latch end the old rusty field gate. The bridleway gate was installed because riders had been finding the field gate impossible to negotiate on horseback as it had to be dragged along the ground.

The closing times of the gate from 90° were measured three times in each direction as follows:

With gate opened to North: 5.83 seconds, 5.64 seconds, 5.05 seconds

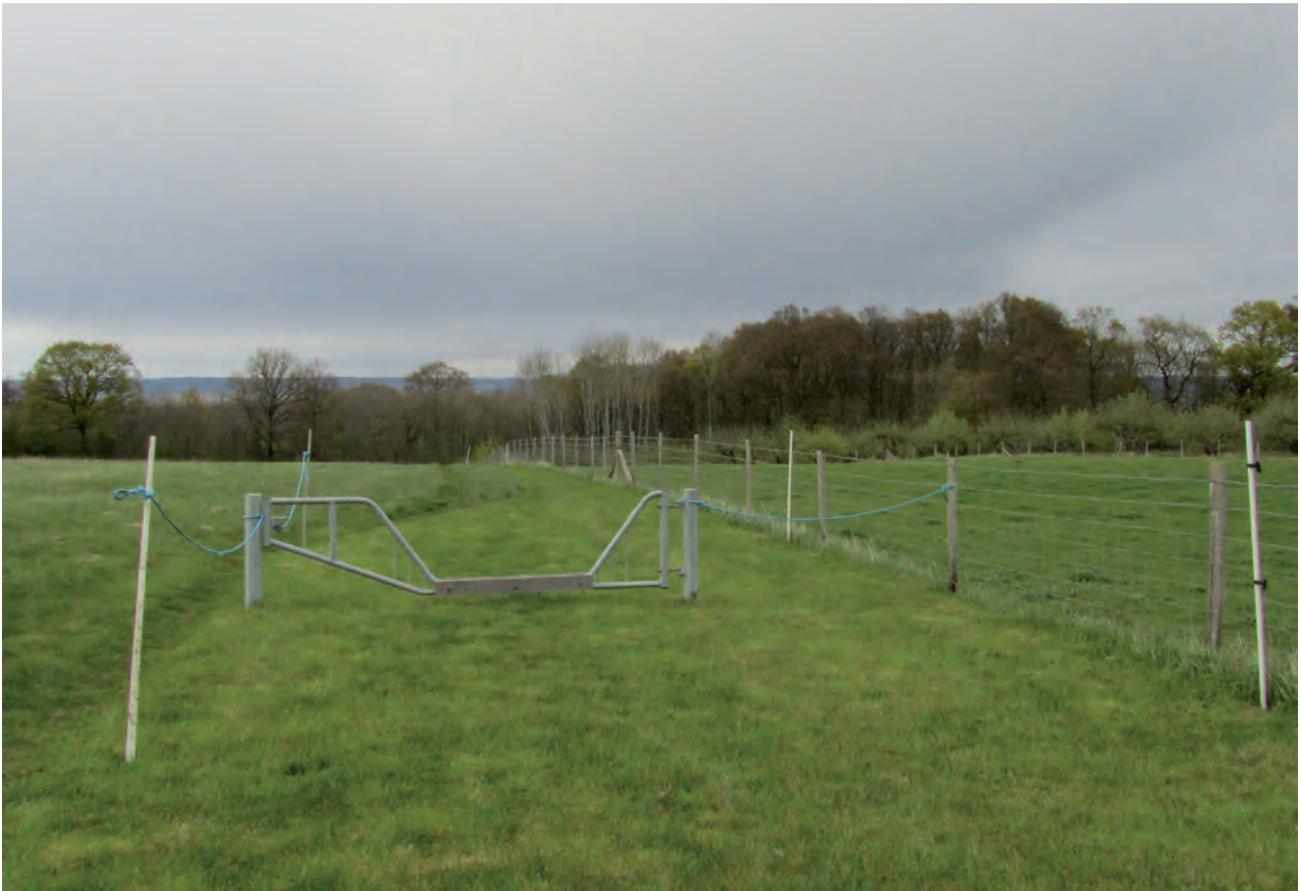
Installed height to top of wooden section: approx. 250mm at centre

British Standard 5709:2006 height for bars of horse stiles: 190mm \pm 60mm, i.e. 250mm max

The barrier was installed 2.1 metres away from the fence at the edge of the field, and the gap between the barrier and the fence was roped off. Pairs of white electric fence posts were placed four metres away from the barrier in each direction of travel, and on the field side a rope joined the electric fence posts to the barrier, to simulate a hedge or fence line. Participants were asked to visualise an imaginary line, parallel with the barrier, between the white posts as the edge of a busy road. They were asked to walk their horse over the barrier and to stop before their horse's nose crossed the imaginary line (before their horse's head would be hit by the imaginary passing traffic for example). They were recorded on video while they attempted to do this. The number of attempts taken by each horse and rider to step over the barrier, whether the horse hit the barrier and whether the horse stopped before the four metre mark were recorded.

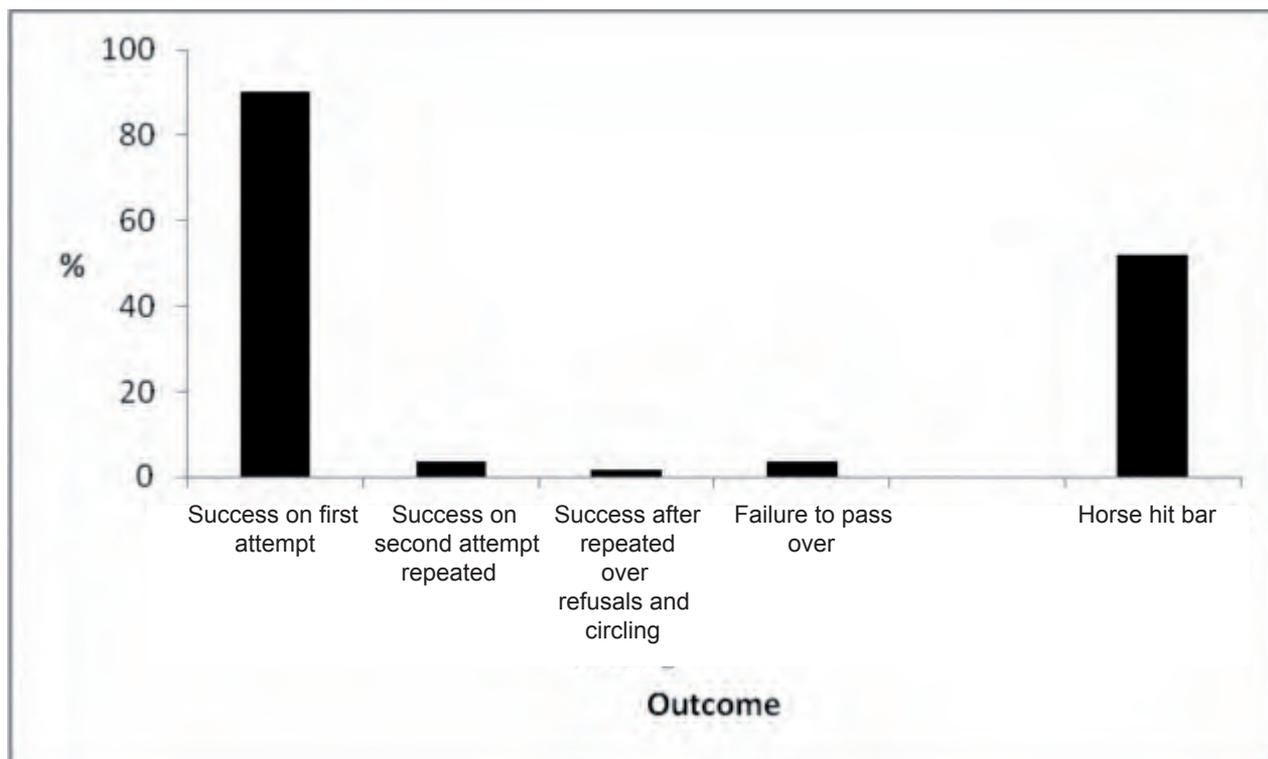
FIG 1(A) Percentage of occasions with various outcomes at the horse friendly vehicle barrier

26 riders attempted the barrier in two directions to give 52 occasions
